Effects of *M* 9 Sumatra earthquake and tsunami of 26 December 2004-A Review

ABSTRACT

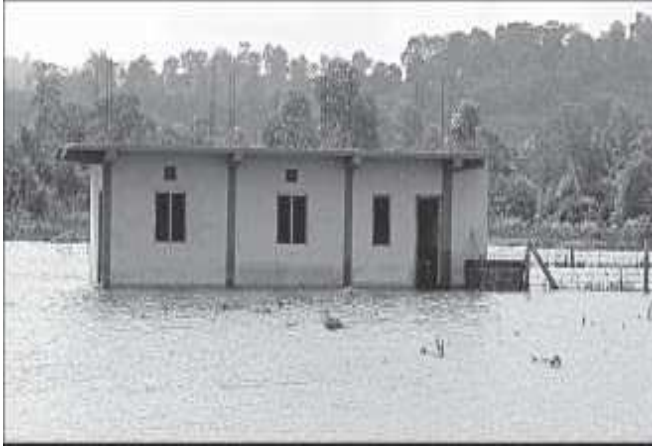
Fig.2 Sea water level at Port Blair with respect to land has gone up by about 1 m.

Due to the subduction of the Indo- Australian plate under the Eurasian plate, the Andaman and Nicobar Islands experienced uplift on the western coast and subsidence on the eastern coast as seen from the field evidence. At Port Blair, located on the east coast, water level has risen by about 1 m, Fig 2. Western coast of the middle Andaman islands showed emergence of new shallow coral beaches suggesting an uplift.

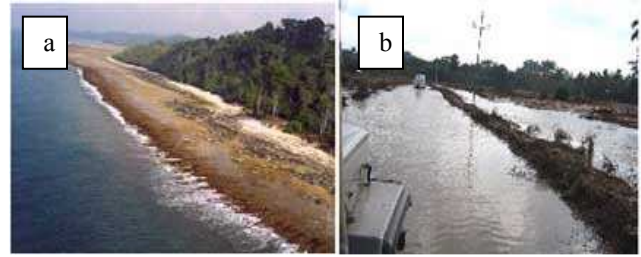
Fig. 3. *a*, Up-throw of coral beds and rock strata due to uplift on the western coast of middle Andaman Island near Flat Island *b*, Seawater flooded Andaman Trunk Road at Sipi Ghat area near Port Blair during high tide, suggesting subsidence of the landmass.

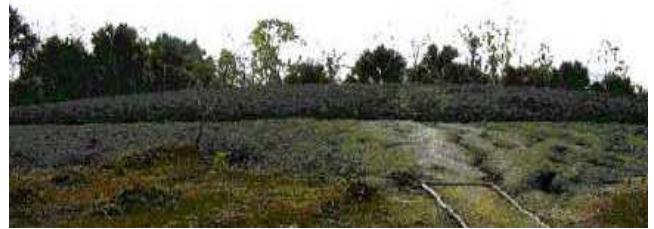
Fig.4 Eruption of a mud volcano near Jarawa creek at Baratank Island Middle Andaman 105km north of Port Blair

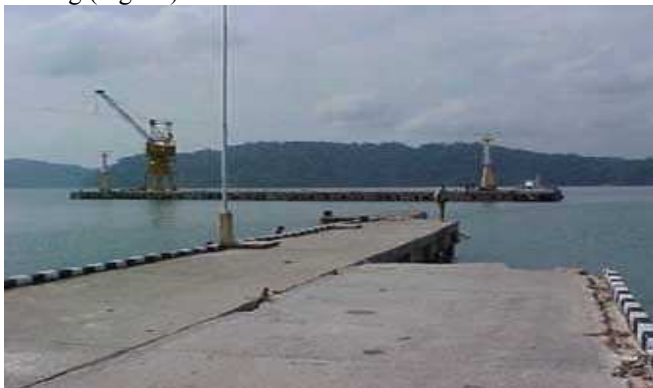
A number of jetties collapsed were severely damaged in a number of islands which severely affected the sea traffic and hence the relief operations (Fig. 7). A new 268 m long bridge between North Andaman and Middle Andaman at Austen Strait had to be closed to even the light vehicles. The superstructure has moved on the substructure by a substantial amount and middle three spans fell off from the bearing (Fig. 8a).

Fig. 7 Collapse of the 80 m segment of approach in Great Nicobar Island jetty at Campbell Bay.
